20 **OROVILLE DAM CASES**

**DECLARATION OF ROBERT G. BEA IN  
SUPPORT OF PLAINTIFFS' OPPOSITION  
TO DEFENDANT'S MOTION TO STRIKE**

## **Root Causes Analyses of the Oroville Dam Gated Spillway Failures and Other Developments**

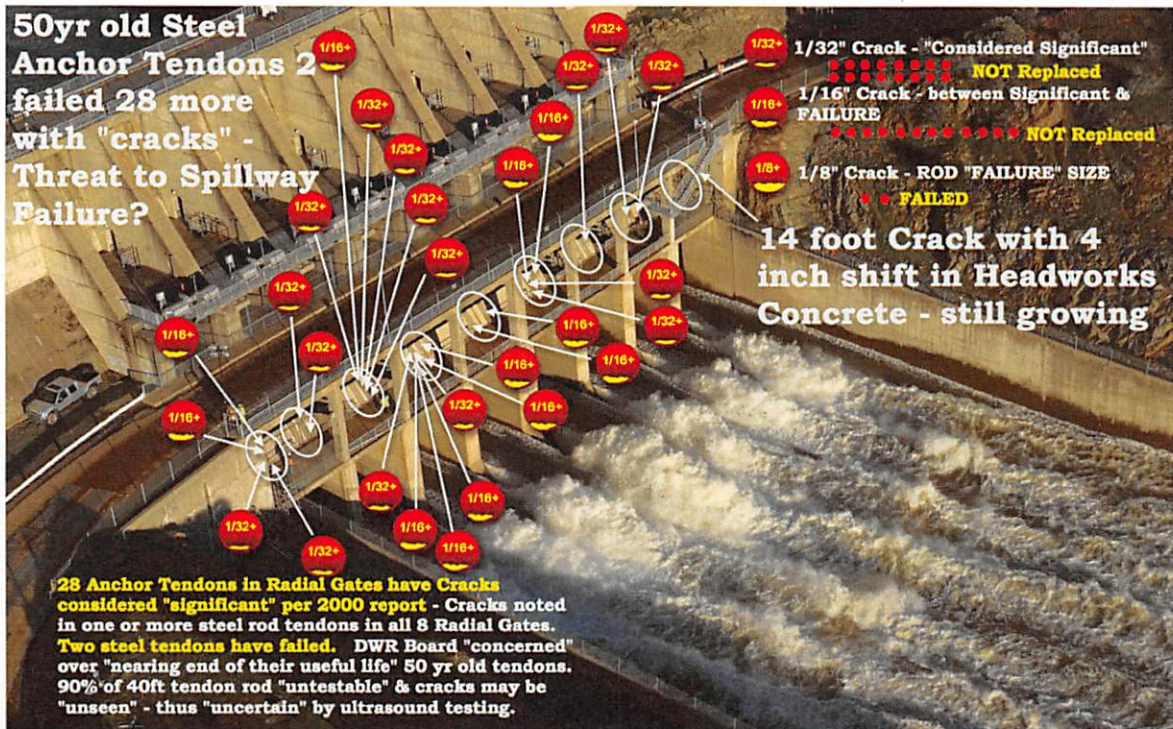
Figure 1: Broken (2) and cracked (28) spillway gate control anchor tendons.

Near 14 foot Crack has shifted a seam close to 4 inches in offset in a 5 foot thick, solid concrete Pier. This crack is growing. Inspectors monitor the crack growth with red paint. Crack is just above array of anchor tendons for Radial Gate 8 Trunnion Anchor. Further cracking may threaten tendons.

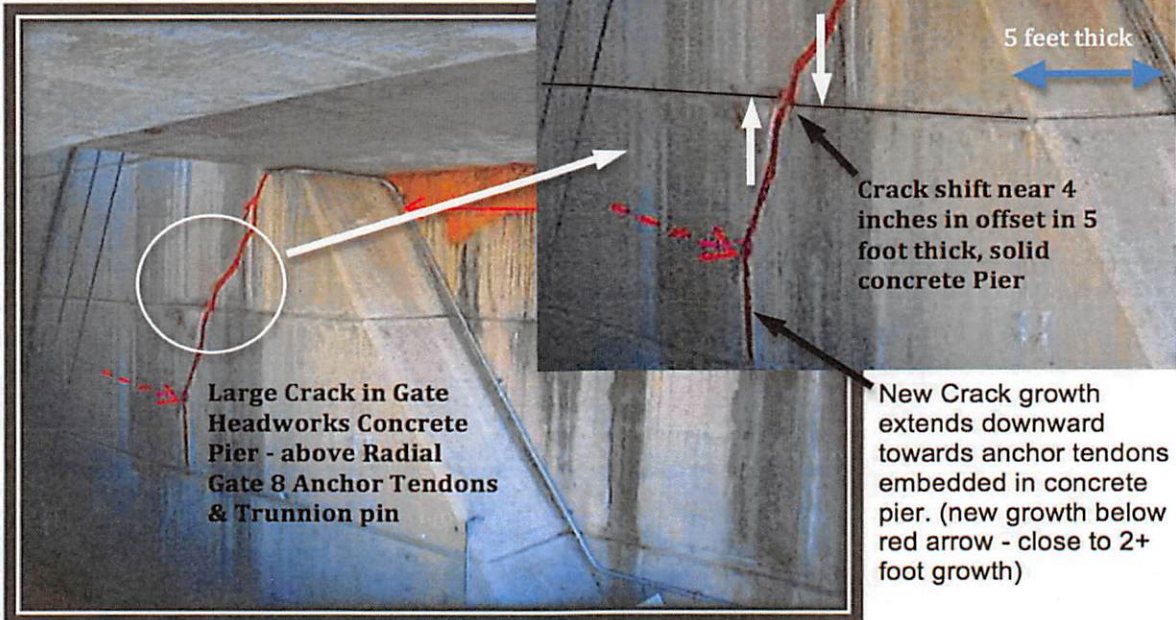
Figure 2: Gate Headworks cracked reinforced concrete pier support structure.

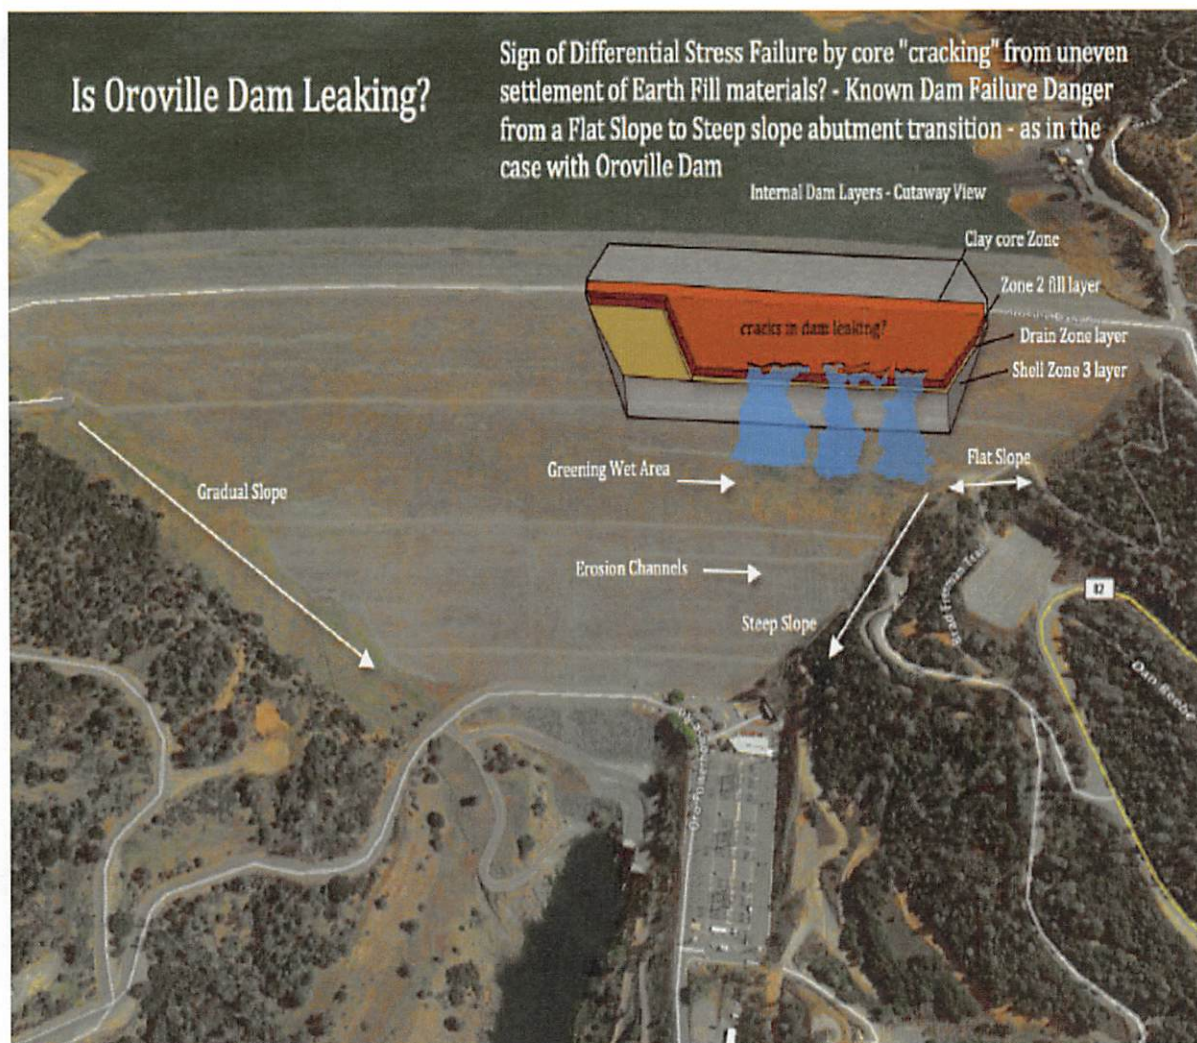
We have reviewed DWR – DOSD – FERC Oroville Dam inspection reports covering the period 2008 – 2016. These reports contain a series of photographs that show the continued development of 'Leaks' and 'Wet Spots' near the dam abutments (Figures 3, 4, 5).

Figure 3: Does the water 'seepage' in the Oroville Dam endanger its Safety and Reliability?

DWR - DSOD, and FERC should be required to focus high quality field investigations and detailed analyses of the results from these investigations to determine and confirm if important seepage is taking place in and around the Oroville Dam. If such threats are confirmed, then proven effective remediation measures should be implemented and validated to assure that the dam is 'Safe' and 'Reliable' for current and future use.

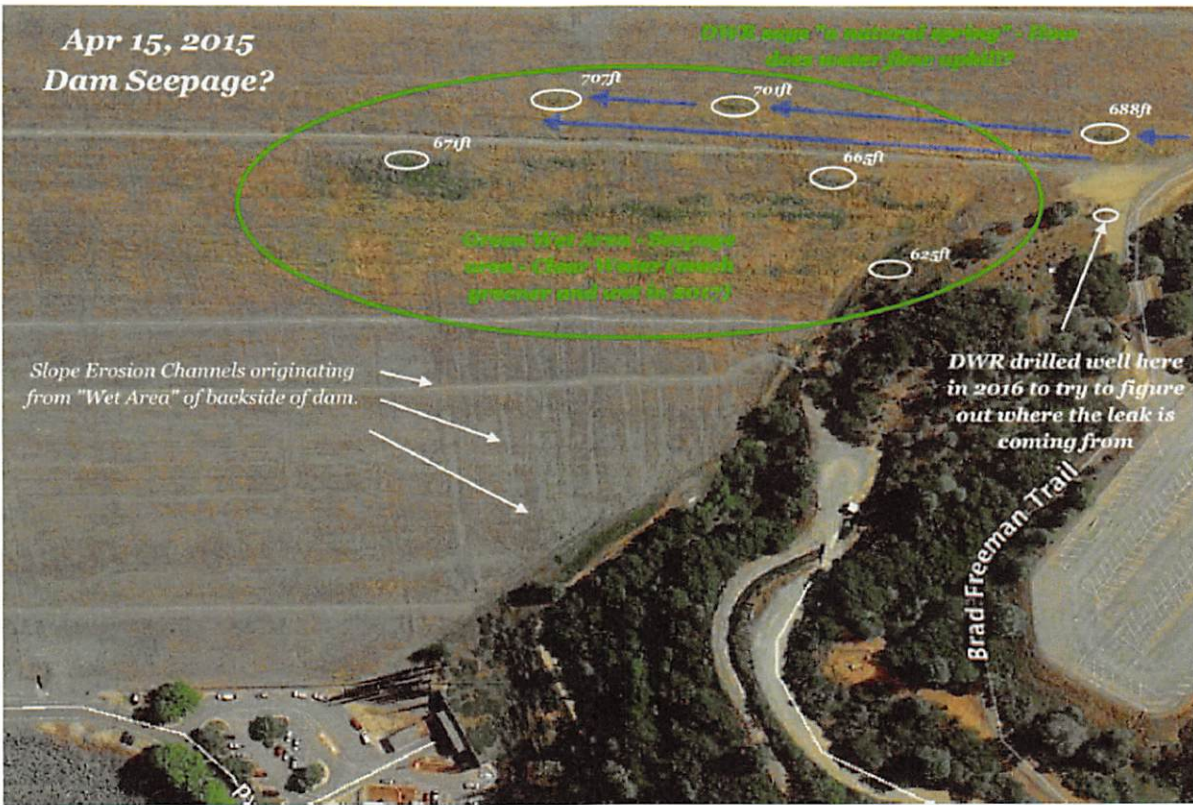
Figure 4: 2015 image of vegetation following an upward elevation slope away from the left abutment. Erosion channels, greenage locations, non-greenage above and below and up the embankment, uphill water flow, contradicts against a left abutment spring. Image courtesy of Google Earth.

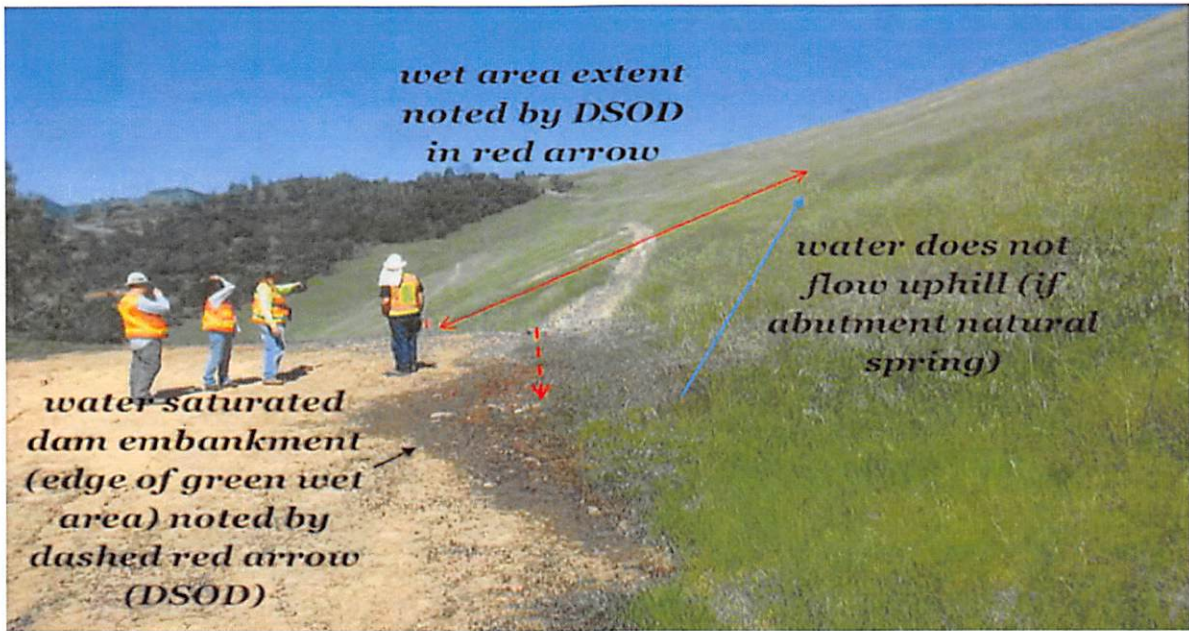
Figure 5: Water does not flow uphill if the dam abutment ‘wet spot’ is a “natural spring.”
